NBS CIRCULAR 550

**Mechanical Failures
of Metals in Service**

For many years the National Bureau of Standards has made examinations of metal parts that have failed in service for evidence bearing on the causes of failure. Thirty-five such cases, representing the most frequently observed types of failures are described, and the factors of design, fabrication, or use contributing to these failures are presented. The characteristics by which the various types of fractures can be recognized are discussed, and recommended precautions that should be observed to reduce mechanical failures of metals in service are included.

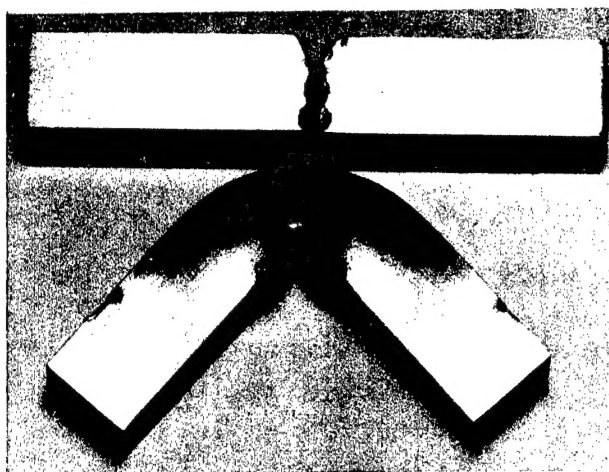
FIGURE 1. *Effect of geometry on the ductility of a steel specimen.*

Identical specimens with a notch in one side were loaded by supporting the ends and striking the middle with a heavy pendulum. The upper specimen was struck on the side opposite the notch; the lower one on the side containing the notch. $\times 2$.

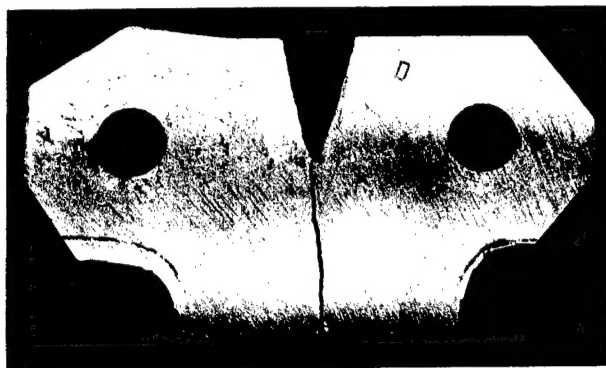
FIGURE 2. *Notched specimen broken in tensile test in the laboratory.*

Holes were used to apply the load in line with the bottom of the notch. $\times 1$.

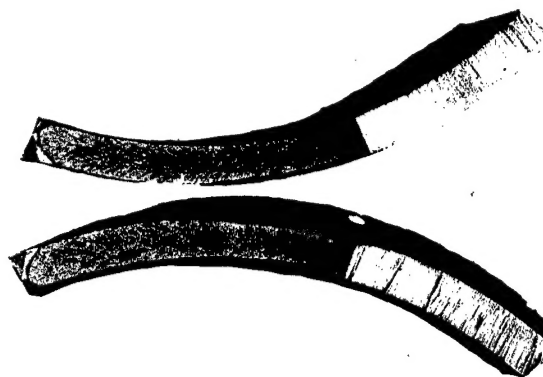
FIGURE 3. *Fractured surfaces of specimen shown in figure 2.*

The specimen broke by tearing from the root of the saw-cut notch, and it will be noted that the "chevron" markings point toward the source of the fracture. $\times 1\frac{1}{2}$.

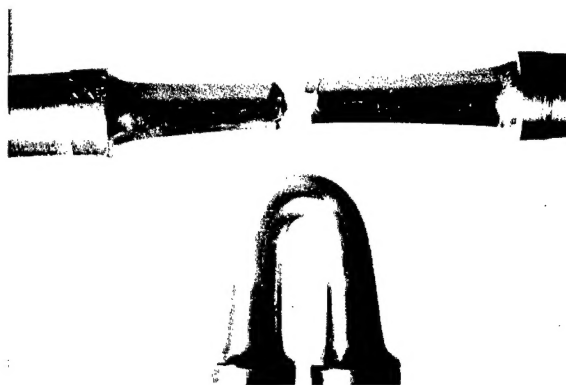
FIGURE 4. *Effect of repeated stress on ductility.*

Identical specimens were loaded by bending. The upper one was subjected to many cycles of reversed loading, and failed with a typical fatigue fracture, showing no ductility. A single high load was applied to the lower specimen, which bent without breaking. $\times 2$.

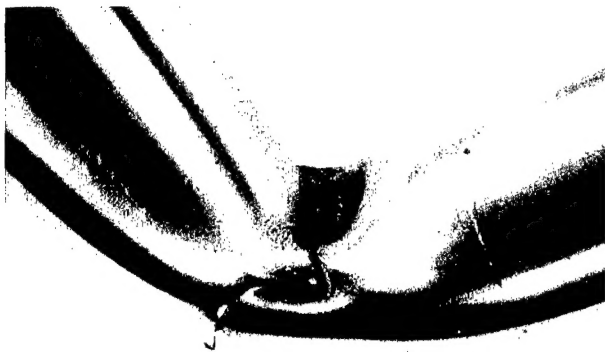
FIGURE 2.1. *Fractured piston parts fitted together in approximately the position they had occupied at the time of final fracture.*

The extensive plastic deformation that had occurred prior to fracture is evident. $\times 1$.

Case 2: Landing-gear retracting-strut piston (steel, chrome-plated). History of material was not available, but it is thought that this fracture was not a primary failure. This example is included to illustrate the characteristics of fractures due to overload. The tubular part, originally straight, had bent through approximately 75° before final fracture occurred. The extent of the plastic deformation can be seen by the checks in the chromium plate.

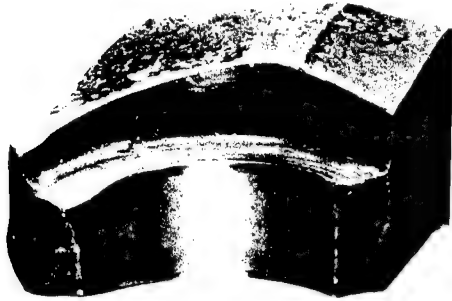
Case 8: Wing hinge fitting (SAE 4340 steel). The extremely coarse grains visible on the fracture surface on one side of the lug, and the intergranular oxidation in this area was apparently caused by severe local overheating after forging but before heat treating. The resultant structure had so little intergranular strength that it fractured under normal service loads.

FIGURE 8.1. *Fractured lug showing a brittle fracture on the right and a normal ductile fracture on the left. $\times 1$.*

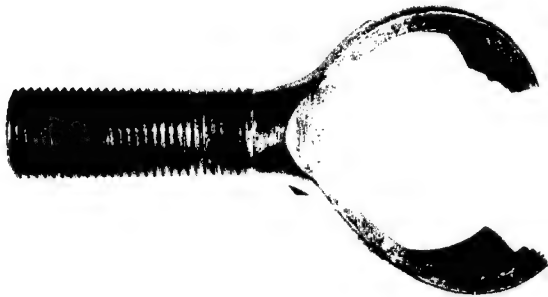
Case 11: Rod end bearing from the wing strut of a light plane (free-machining steel). Fracture of part during apparently normal flight caused a crash. The numerous large inclusions in this material greatly reduce its ductility transverse to the rolling direction. The fitting was cut from bar stock, so that the inclusions were parallel to the length of the shank. Thus the tensile stress at the top of the eye was applied in a transverse direction, and the strength of the thin section was inadequate to support normal flight loads. In order to avoid loading in a transverse direction in a part of this kind, it is generally necessary to use a properly designed forging. The free-machining steels are unsuitable for critical parts subject to high stress in service because of poor transverse properties and great variability.

FIGURE 11.1. Rod end bearing which fractured in service. The fracture showed almost no local ductility. $\times 1$.

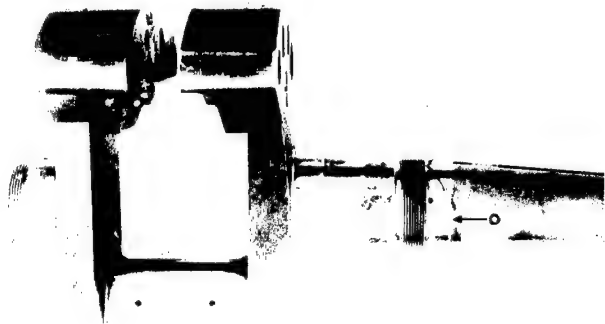
FIGURE 15.1. *Crankshaft with broken parts fitted together.*

Case 15: Aircraft engine crankshaft (alloy steel). The crankshaft fractured after a total of 220 hours of service. The fatigue crack originated in an area where fretting had occurred under the propeller hub. Fretting is the term given to the action that results in surface damage when there is relative motion between solid surfaces in contact under pressure. The action may be produced by extremely small motions and causes a severely pitted condition of the surface. In this case the pits concentrated the stress to such an extent that the peak stress was greater than the fatigue strength² of the steel.

The fracture originated at arrow "o" in an area where rubbing had occurred. $\times \frac{1}{4}$.

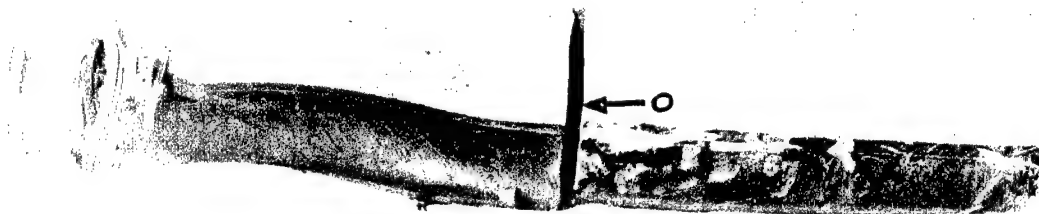
Case 23: Aircraft propeller blade (steel). The hollow blade failed due to a fatigue crack that originated at one of several defects on the inside of the blade. These defects, which occurred prior to heat treatment and painting of the blade, appeared to have resulted from a gouging, or galling, action, probably due to scraping against a mandrel.

FIGURE 23.1 *Flat side of the broken propeller blade.*
The fatigue crack started on the inside surface near arrow O.

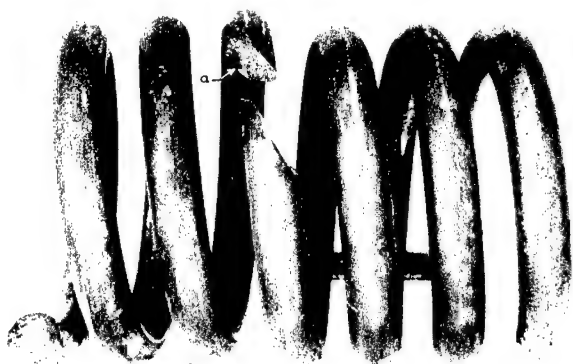
torsional stress. In the absence of stress raisers, the first cracking in torsion usually occurs in planes of maximum shearing stress, which are parallel and perpendicular to the length of the rod. Because of the directional properties of the rod from which the spring was wound, the resistance to fatigue was less in the parallel direction than the perpendicular, so the crack developed as shown in figure 25.3. When this crack had progressed to a considerable extent, it caused sufficient stress concentration to initiate a crack due to tensile stress in a direction approximately 45° to the length of the rod. This second crack progressed only a short distance before the rest of the section failed due to overload.

FIGURE 25.1. *Fractured helical spring showing the origin of the diagonal fracture on the inside of the coil at arrow "a".* $\times \frac{1}{2}$.

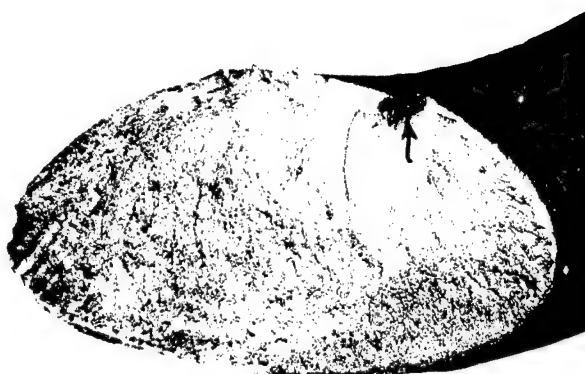
FIGURE 25.2. *Fracture surface on one part of the spring. The small dark area (arrow) is the tension fatigue crack which originated at the longitudinal (shear) crack.* $\times 3$.

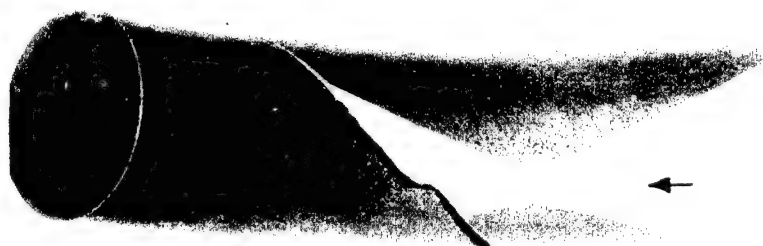
FIGURE 25.3. *The two parts of the fracture fitted together.*

The piece on the right has been ground to show the extent of the longitudinal crack (arrow) away from the fracture. $\times 2$.

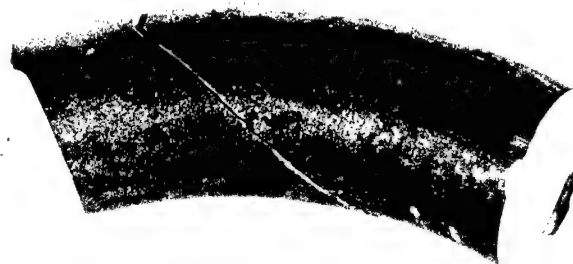
FIGURE 26.1. *Fractured pieces of spring fitted together to show surface pit at nucleus of fatigue fracture, arrow O.* $\times 2$.

Case 26: Helical spring (steel). In contrast to case 25, the fatigue fracture in this spring started on a plane normal to the tensile stress. The surface of the spring was somewhat pitted, and the stress concentration at one of these pits was sufficient to cause the initiation of the fatigue crack. The fatigue crack progressed over nearly half of the cross section of the rod before final fracture

occurred, indicating that the applied stress was relatively low and showing the severe decrease in fatigue strength caused by a surface defect.

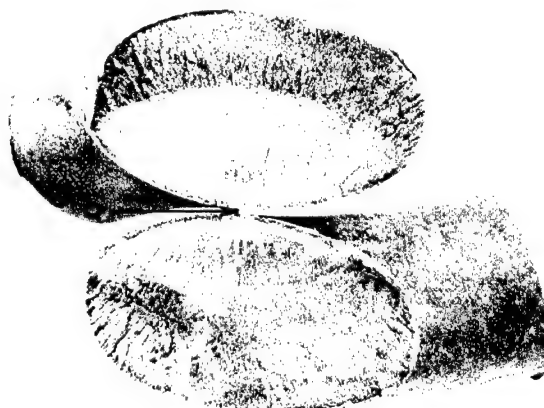
FIGURE 26.2. *Surfaces of the fracture; the fatigue crack progressed from the origin at arrow O across nearly half of the section before overload fracture occurred.* $\times 2$.

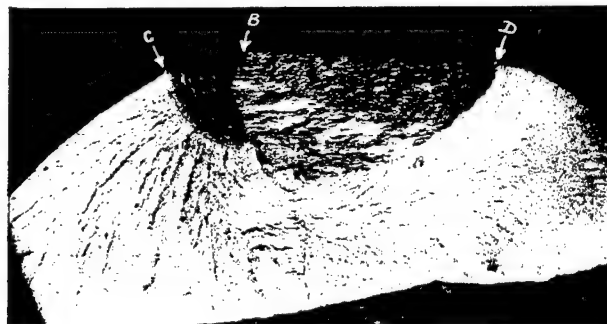
FIGURE 27.2. *Surface of the fracture.*

The dark fatigue crack areas at the top are easily distinguished from the lighter overload portion. The tensile fatigue crack from B to C is on a plane making an angle of approximately 45° to the plane of the paper. $\times 1$.

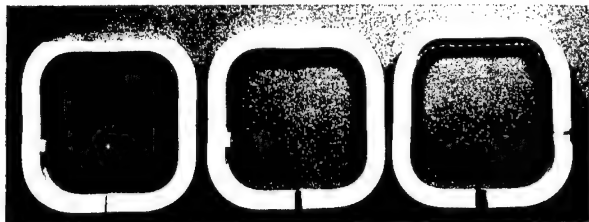
FIGURE 32.6. Three sections cut from one of the tubes to show the presence of internal stress.

In the section on the left the outside half of the wall thickness was first milled off, then the wall was sawed on the opposite side. No change in the width of the saw cut was observed. Tube expanded on being cut when no milling had been done, (center) and expanded still more when the inner half of the wall was removed prior to sawing (right). This indicates that there was a tangential tensile stress in the outer half of the tubes and accounts for the failure of the cracks to penetrate completely through the walls (fig. 32.3). $\times \frac{1}{4}$.

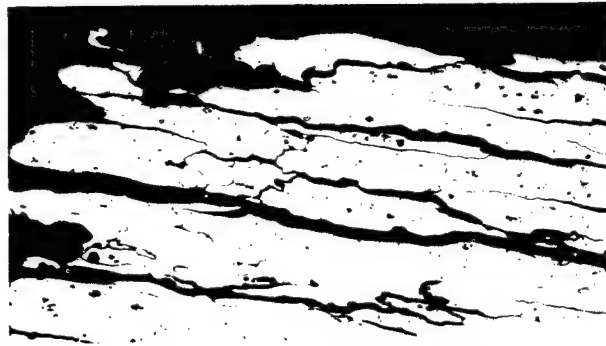
FIGURE 33.2. *Typical intercrystalline corrosion in one of the fittings. Unetched. $\times 100$.*
